# Expect the Unexpected

## Preparing for Water Main Breaks

# November 12, 2012: Water Main Break

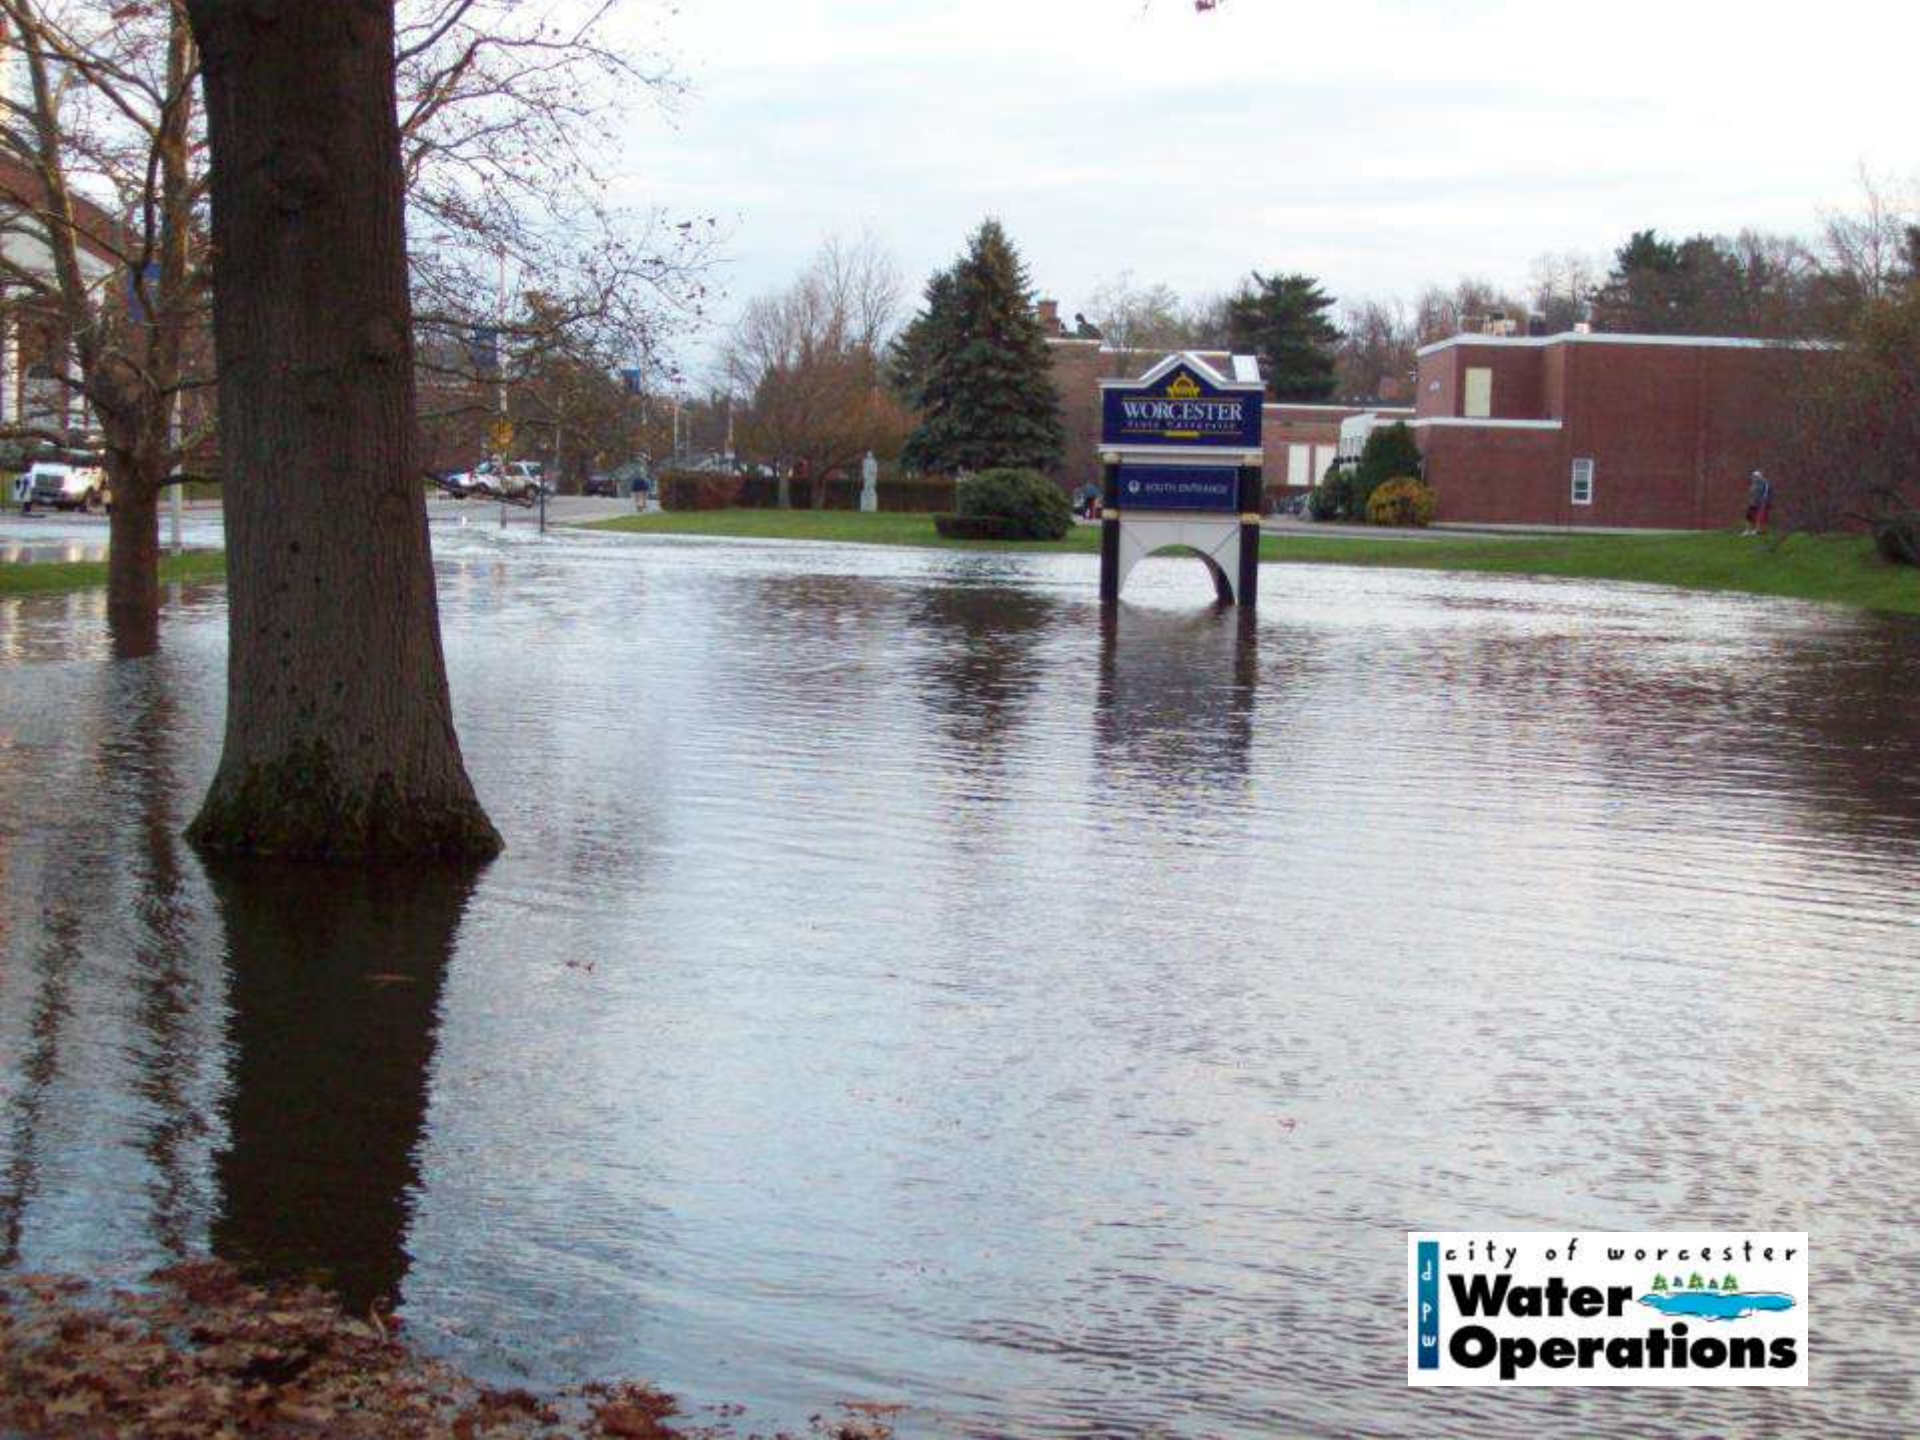
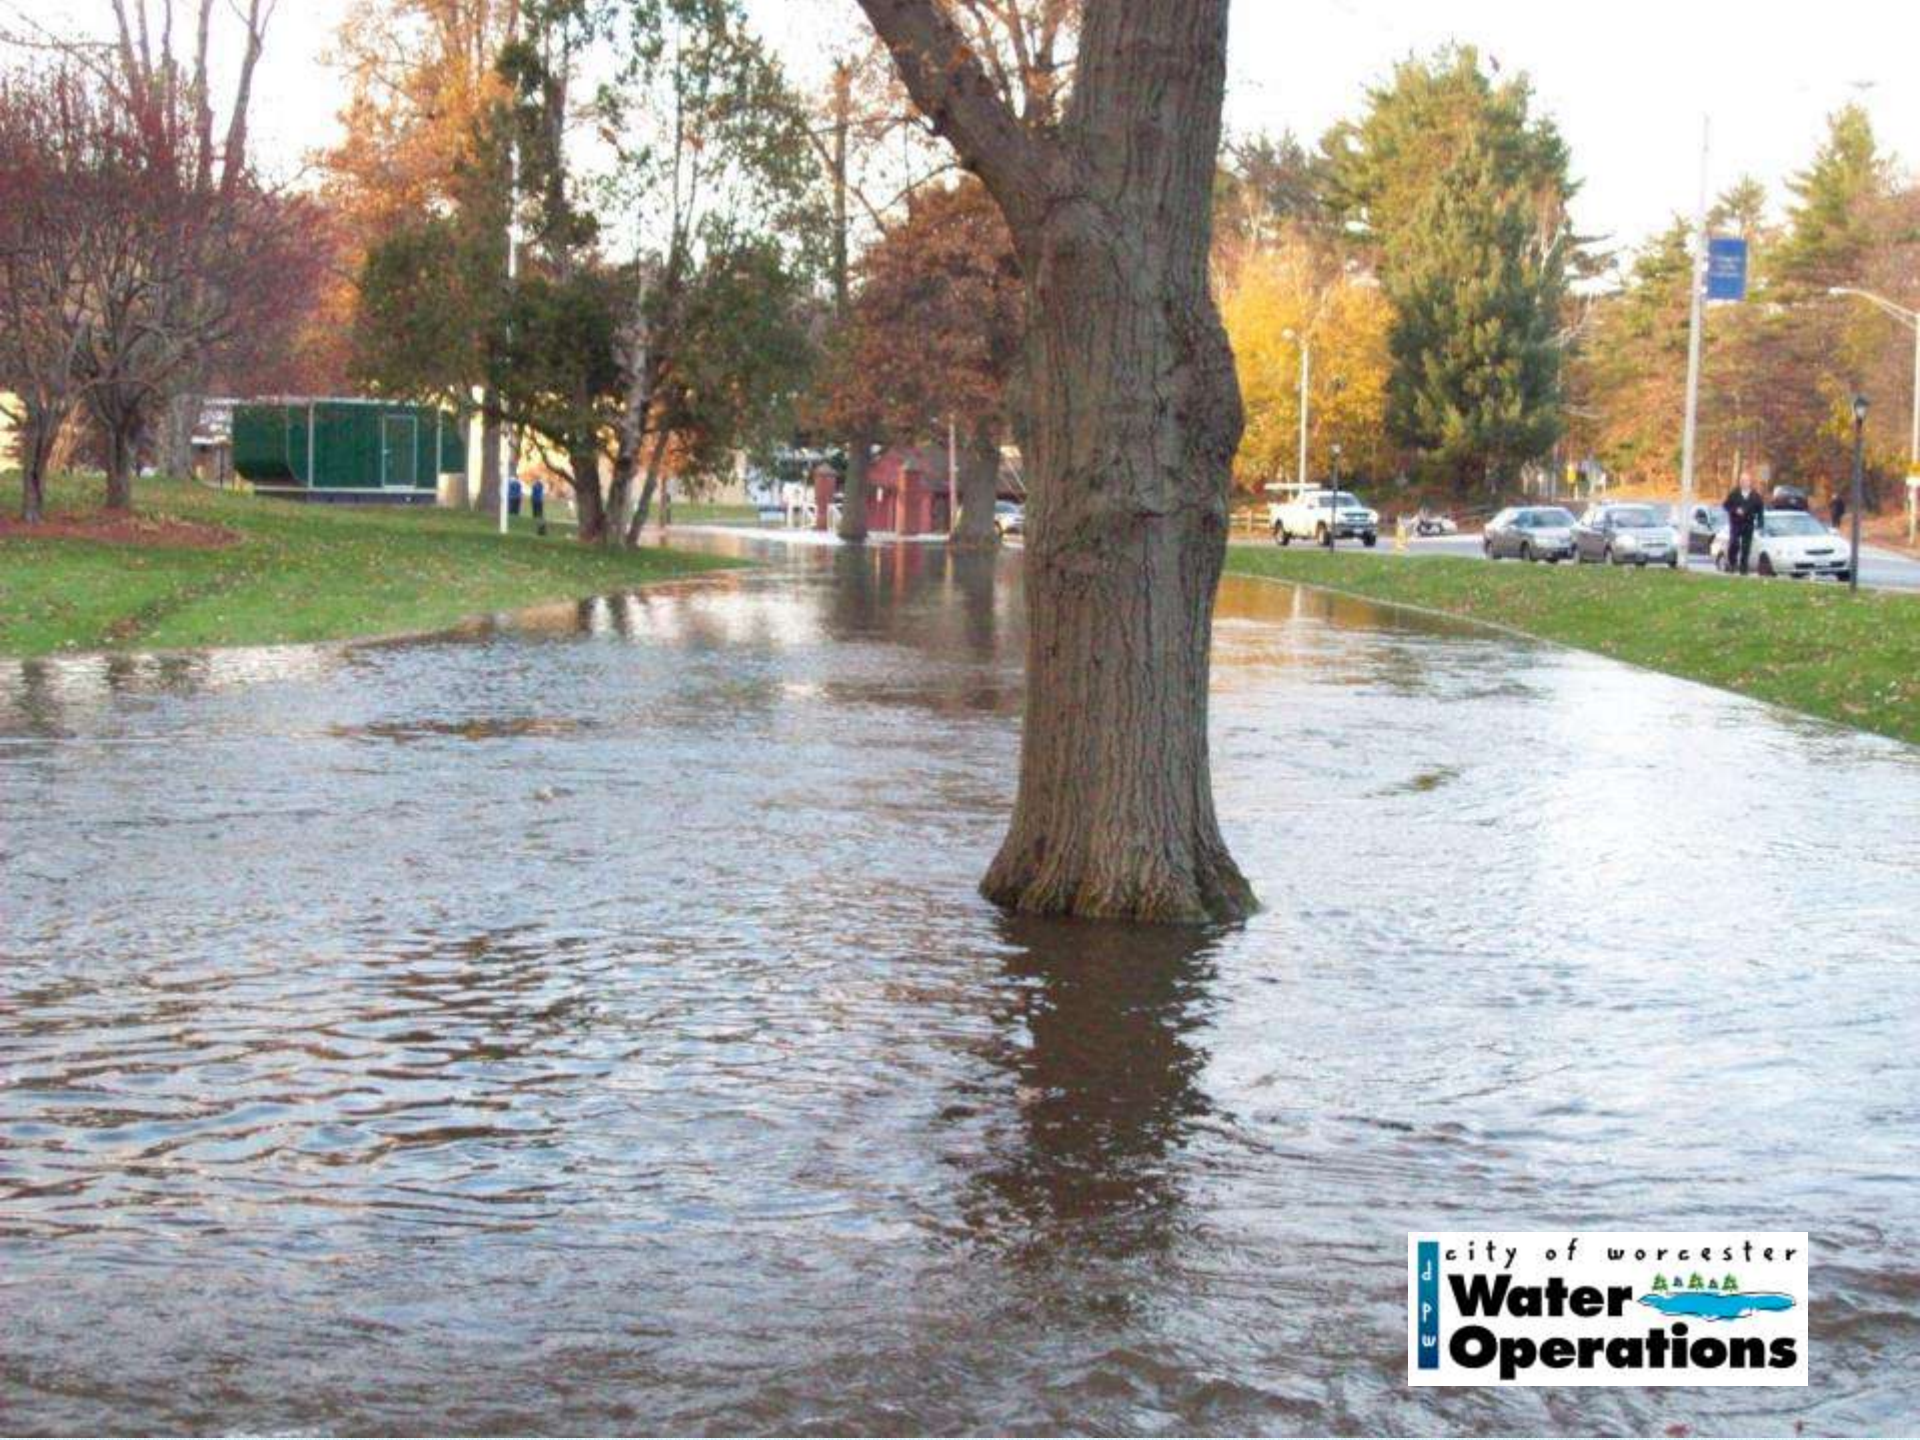
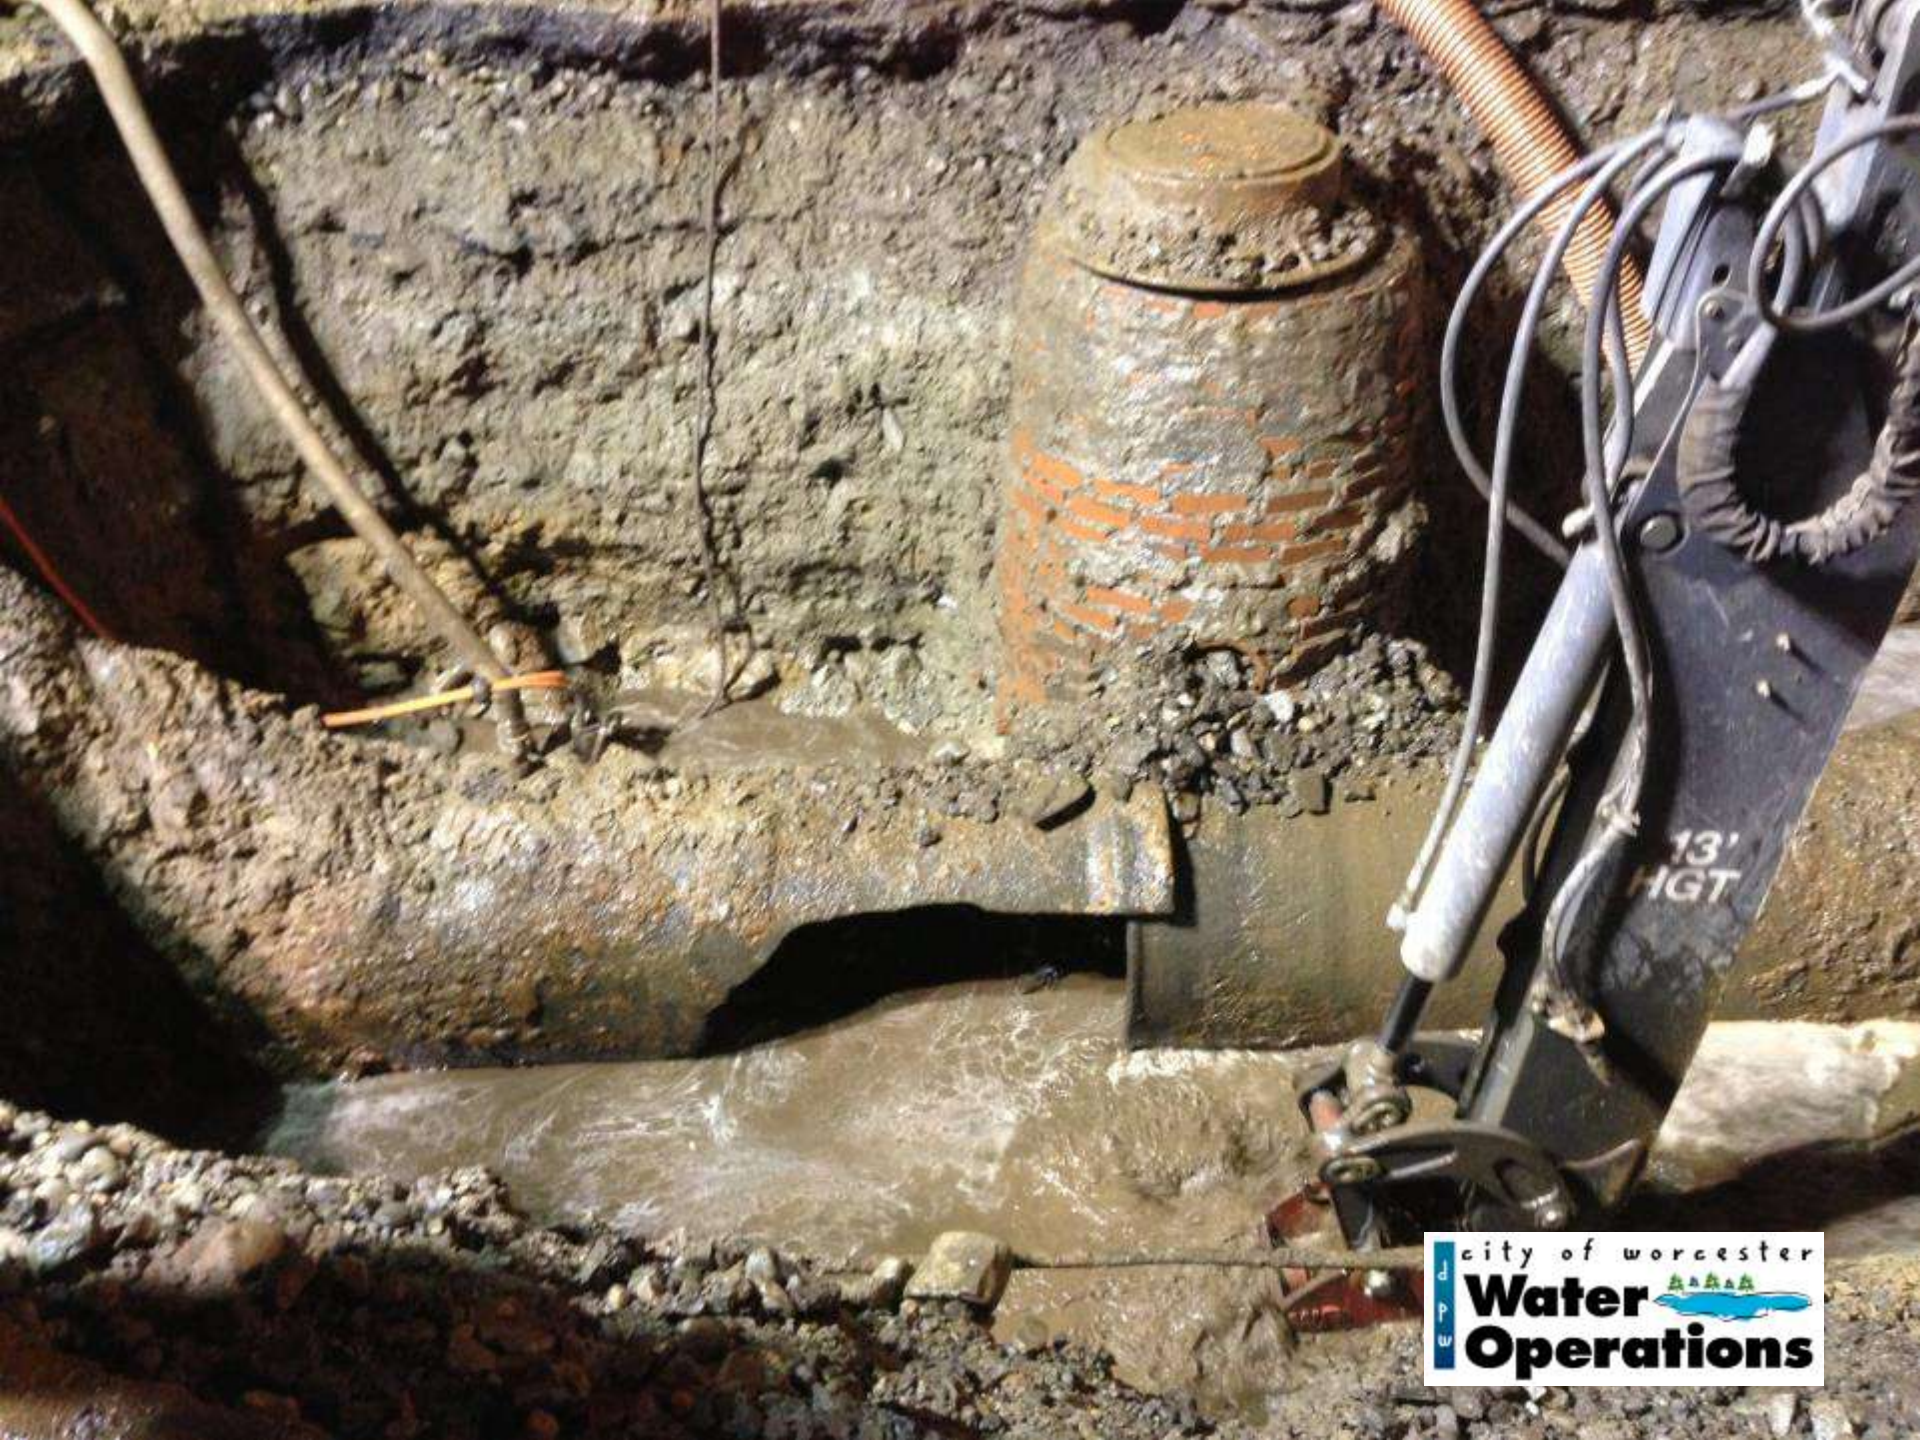
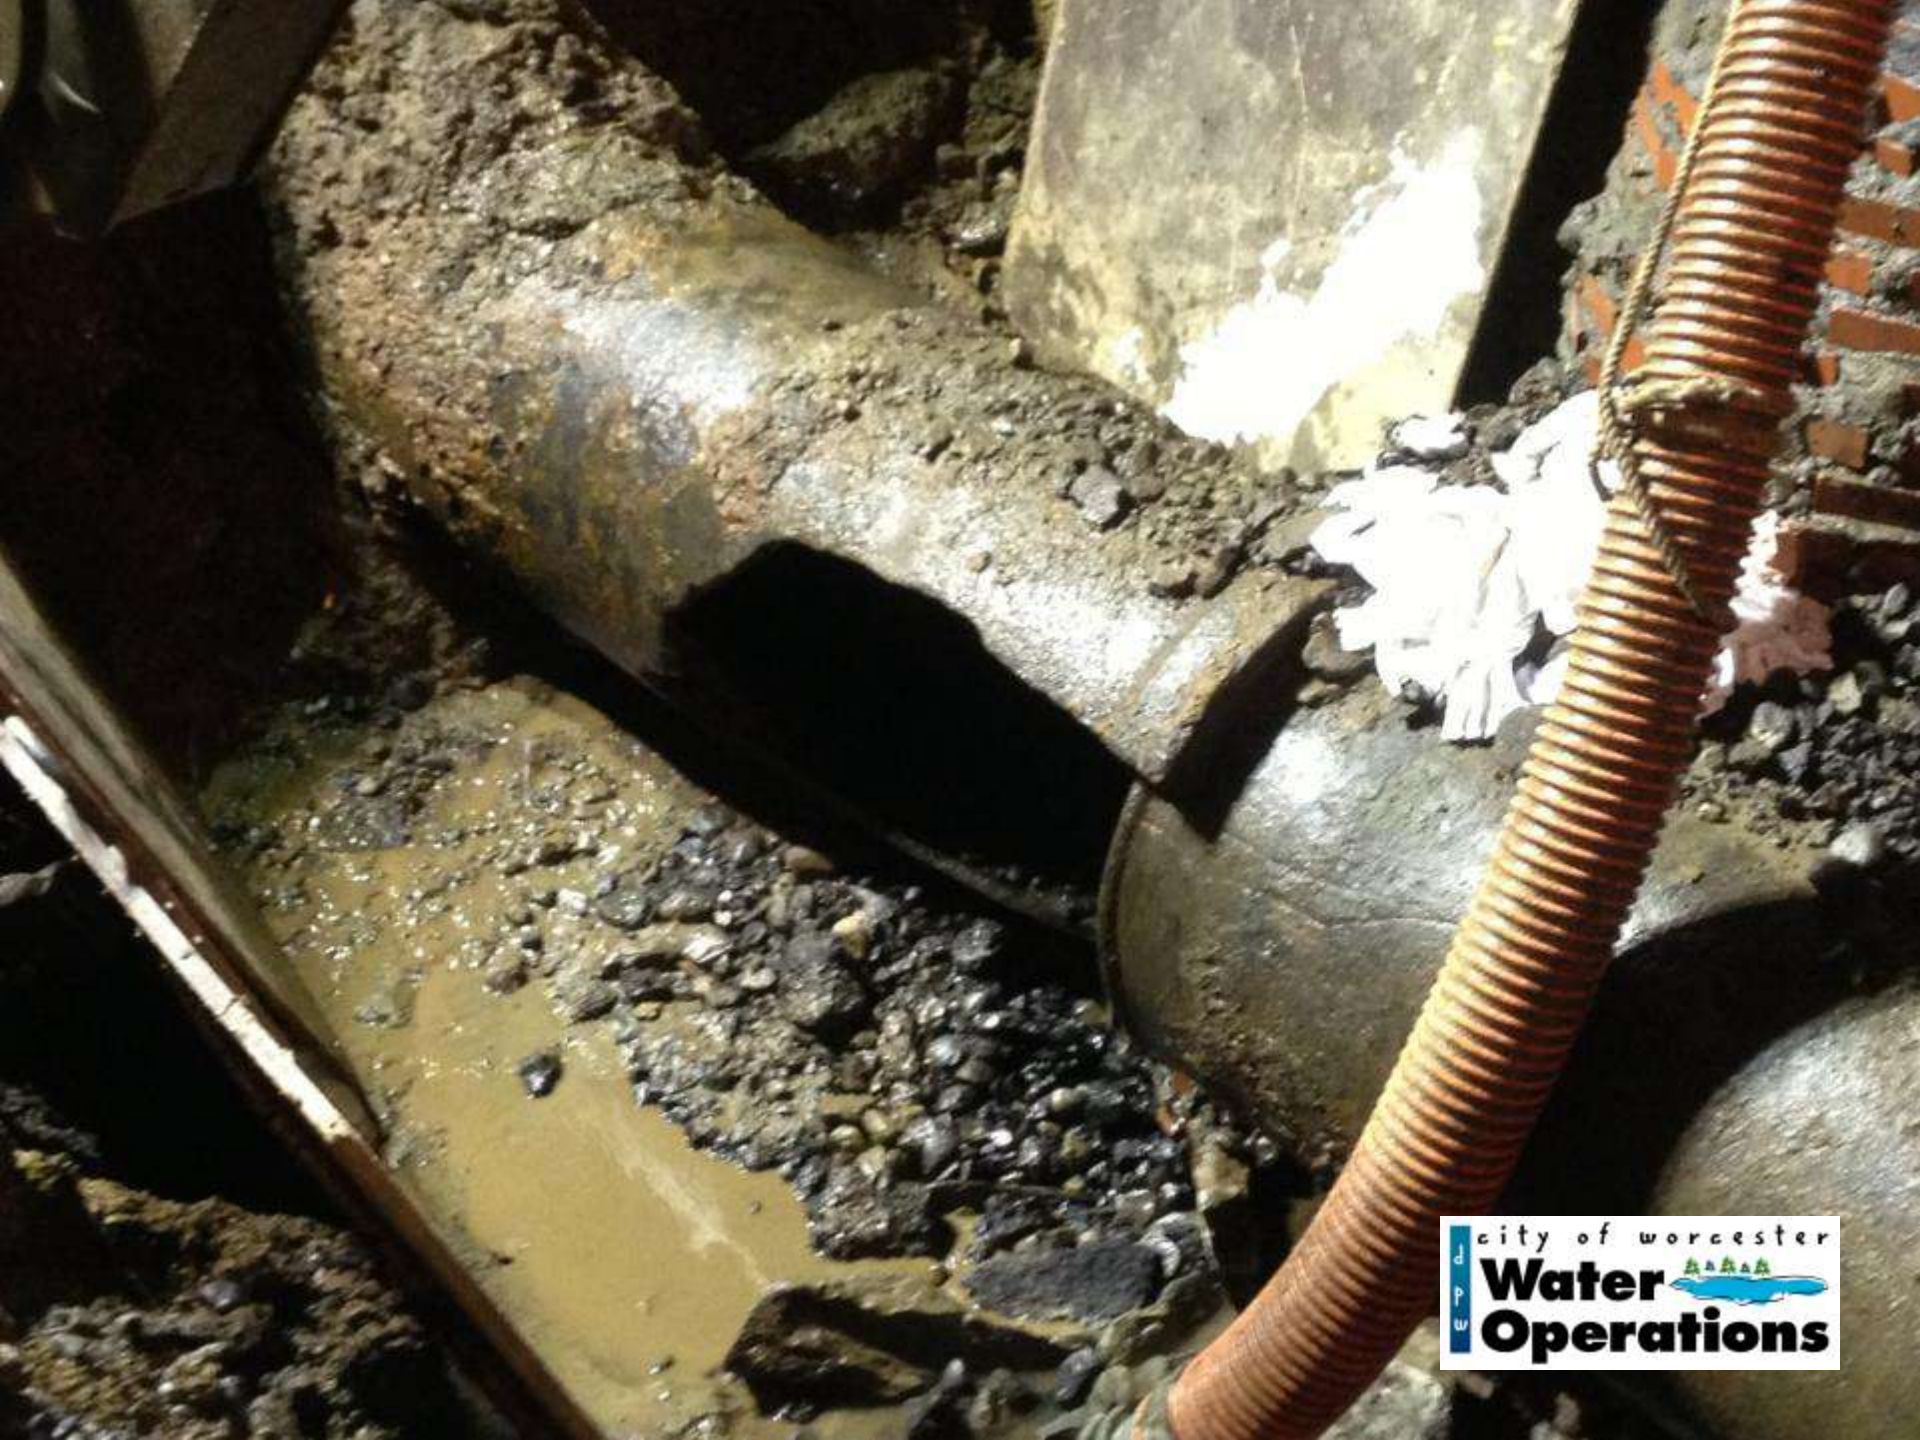
- First reports received at 12:25 PM
- Holiday (Veteran's Day) – Limited Staff
- 30 inch main, cast iron off of a 40 inch main (Low Service Transmission)
- Flooding near break
- Loss of Low Service pressure
- Clearwells drop rapidly leading to the loss of High Service pumping
- High Service Tank levels drop rapidly

- First responder on scene within 30 minutes
- Crew at scene within 1 hour of initial report
- Attempts to shut valves to isolate break unsuccessful
- Order to shut plant issued after 4 hours of attempted valve shutdowns; no flow into City for over 8 hours
- Plant back on line to fill clear wells 6 hours after shutdown; high service pumps on-line 2 hours later
- Broken main repaired and in-service 15 hours after break began
- Staff remain on duty throughout

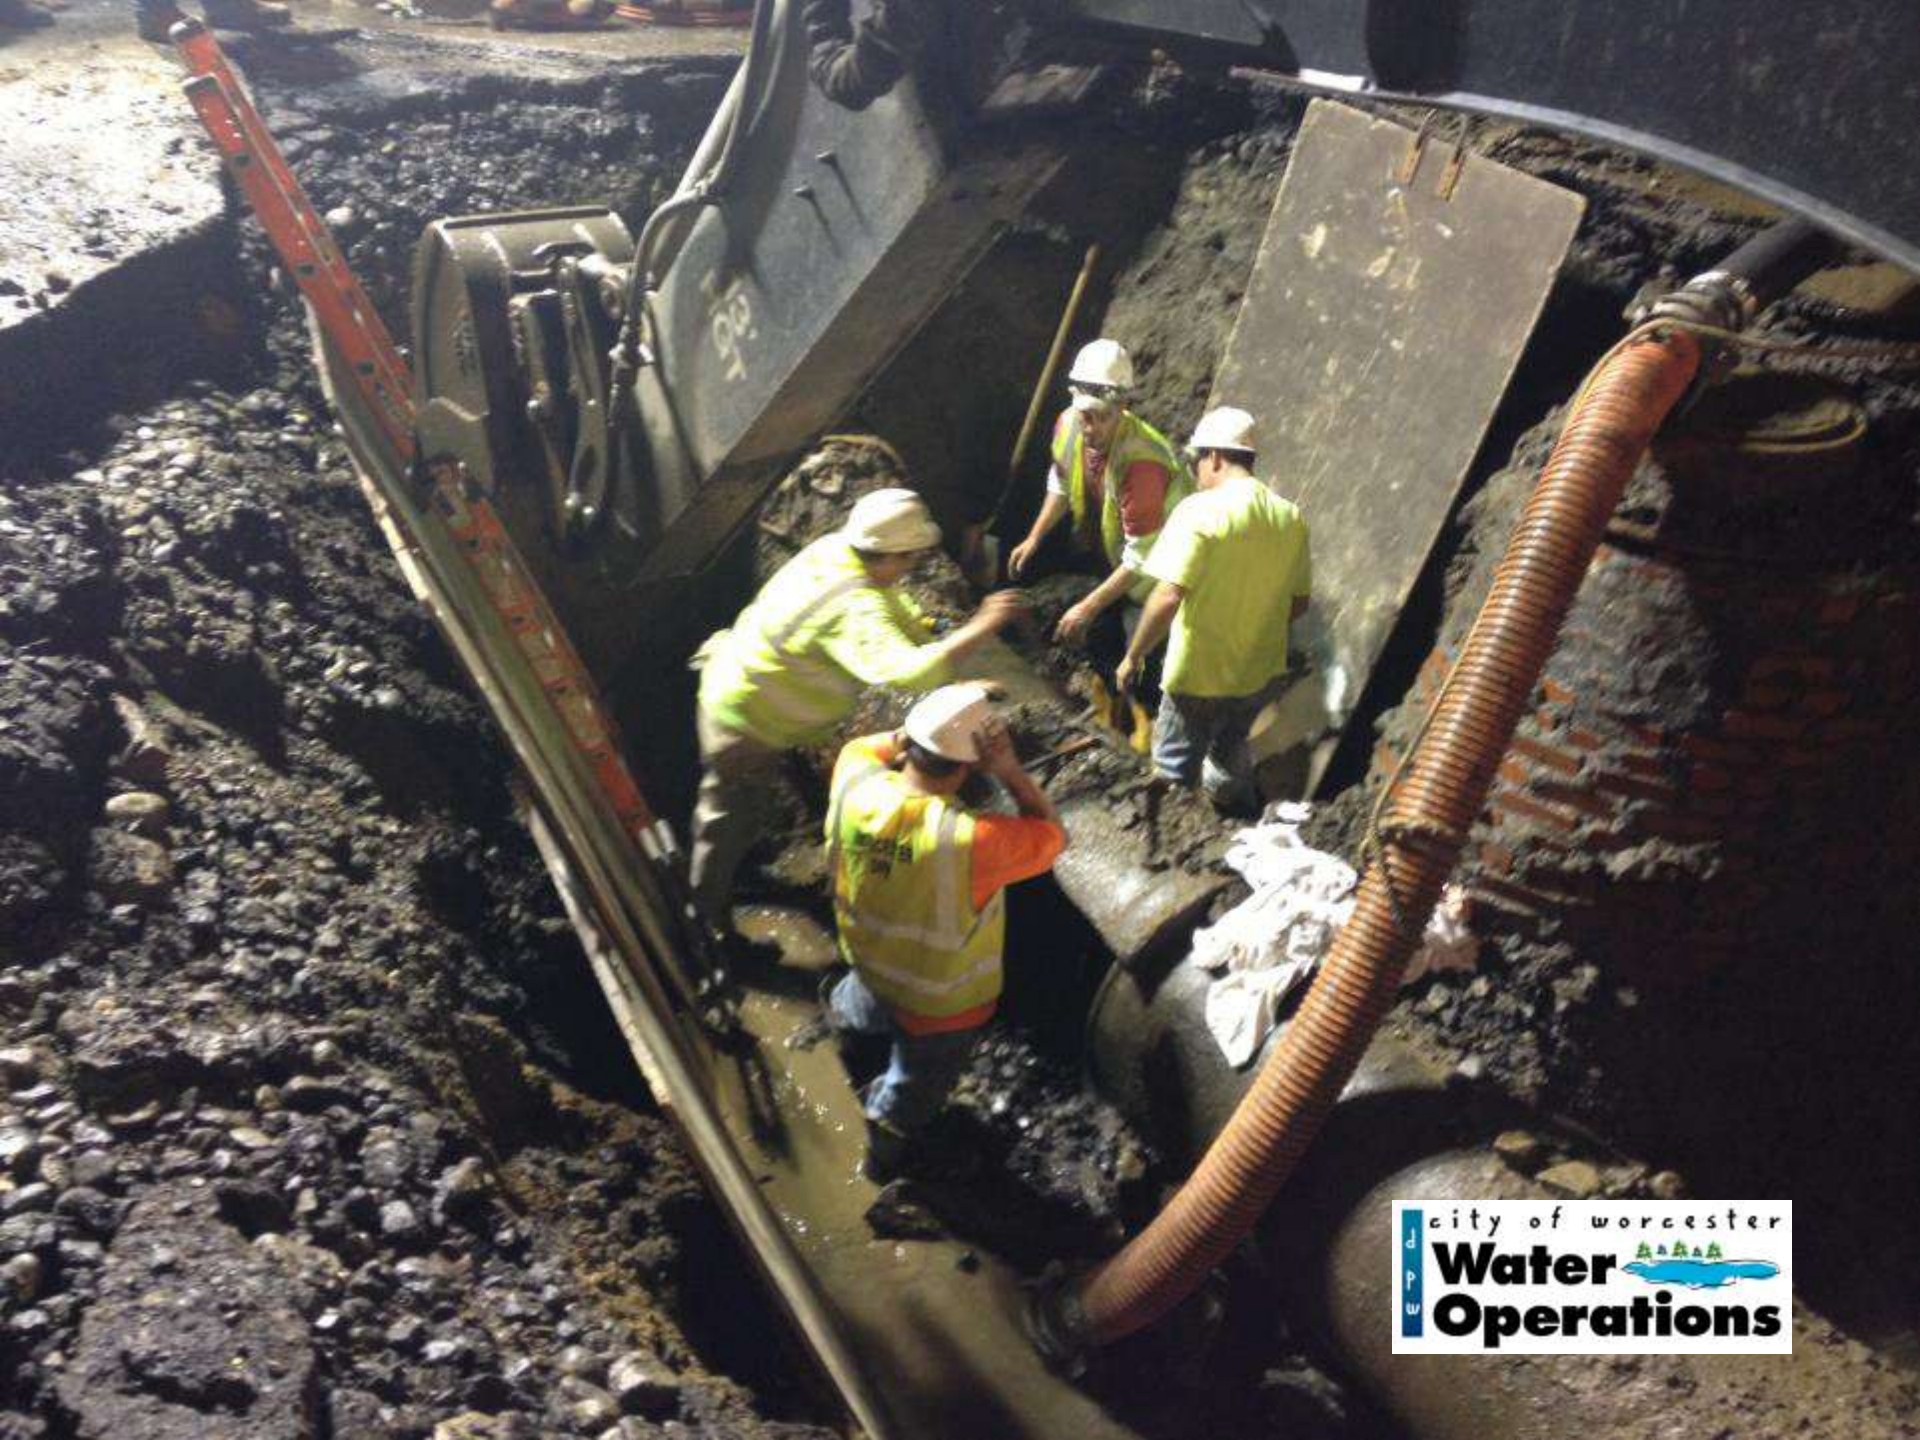
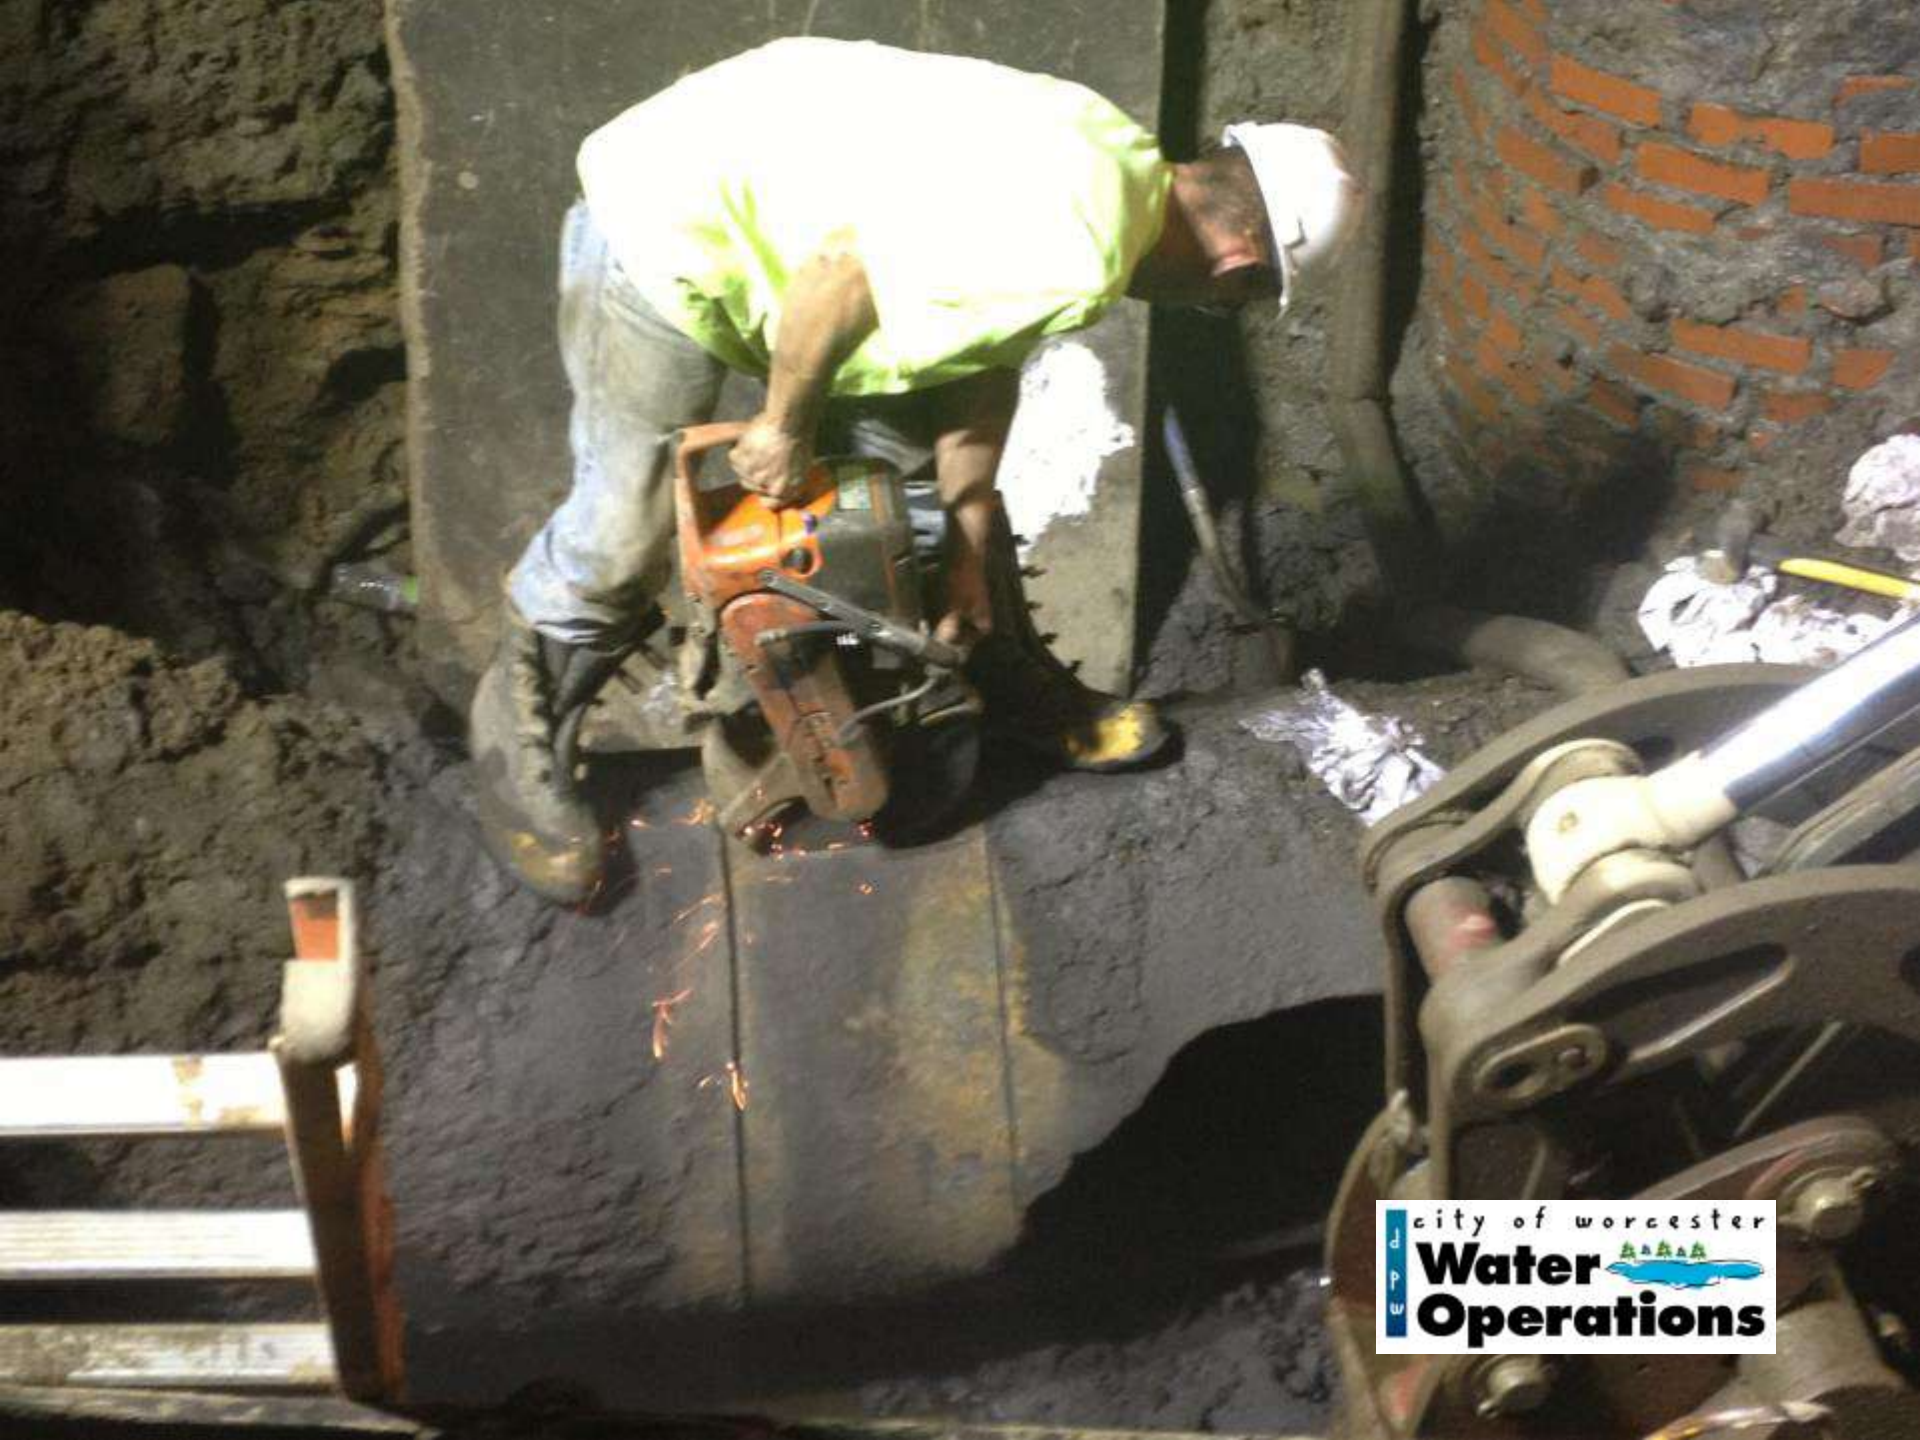
- Fire fighting capabilities compromised; Worcester Fire Dept activates mutual aid to bring tankers from surrounding towns
- Water for sanitary purposes limited; Holy Cross College brings in portable toilets for student use
- Flood damages at Worcester State University
- Hospitals activate emergency plans; limit water use; monitor pressures; cancel surgeries; secure bottled water
- Restaurants close
- Some areas never lost water or pressure
