# Pipe Cameras

Appropriate usage to assist with a  
Title 5 Inspection

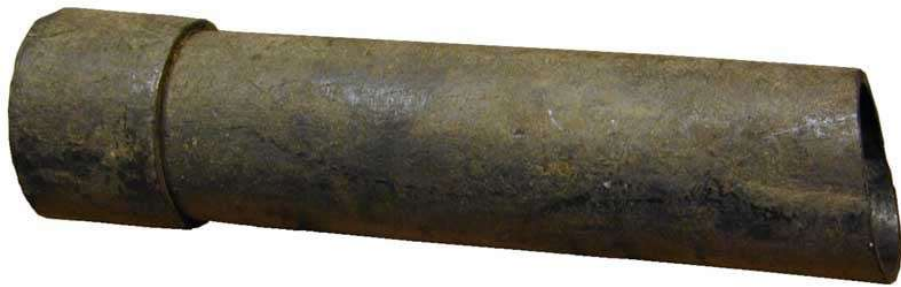
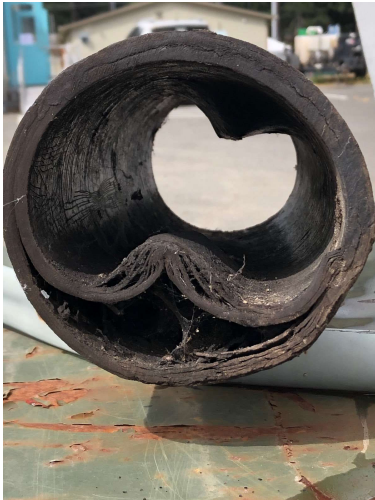
# Orangeburg Sewer Pipe

- ▶ Layers of ground wood pulp fibers and asbestos fibers mixed with liquified coal and tar pitch
- ▶ Typically pre-1970
- ▶ When it fails, it tends to delaminate or flatten
- ▶ Sometimes appearing totally round on the outside, but very deformed on the inside
- ▶ Camera is very helpful with this type of pipe

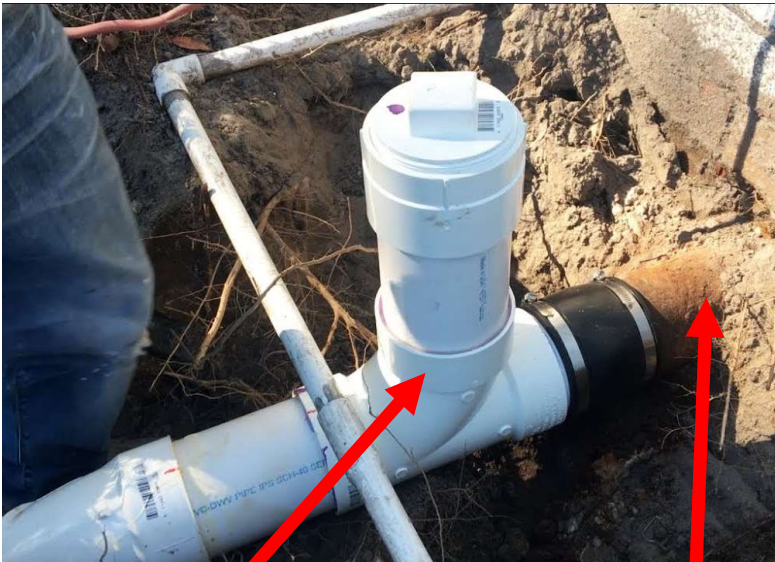
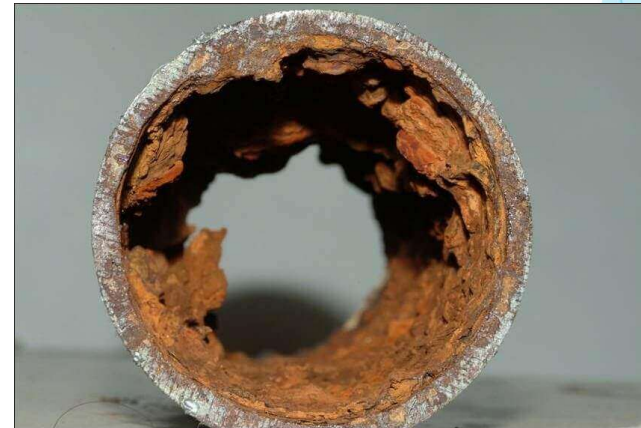
# Cast Iron Sewer Pipe & SCH40 PVC

- ▶ Homes pre-1970 that have been upgraded expect to see cast iron changing over to PVC
- ▶ Cast iron inside diameter tends to get smaller and smaller as it ages, often can only be seen by looking inside the pipe

SCH40 PVC

ORIGINAL CAST IRON

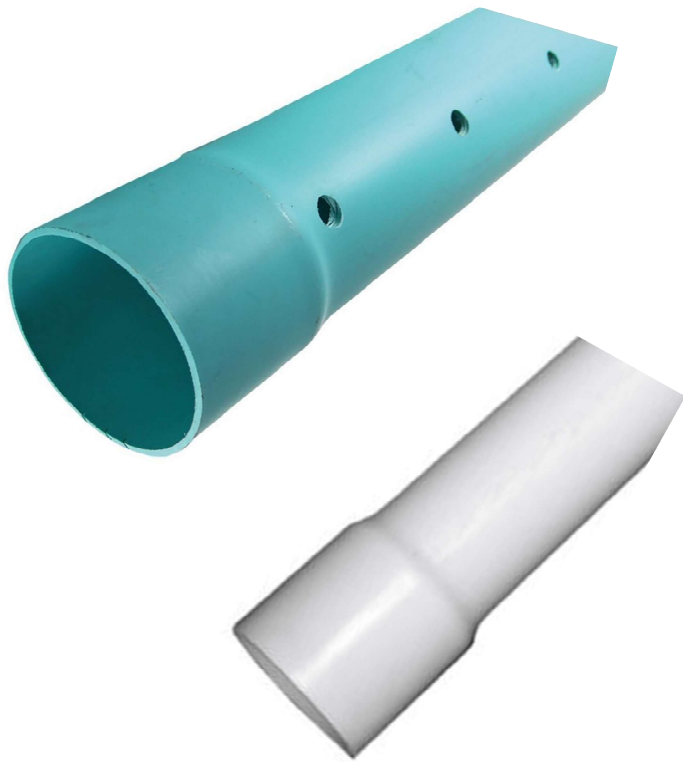
# SDR35 & SCH40 Solid & Perforated

- ▶ Used on almost all septic systems since approximately 1970
- ▶ Corrosion resistant
- ▶ Lightweight, easy to work with
- ▶ Can have sags/ dips in pipes when not properly backfilled during an installation

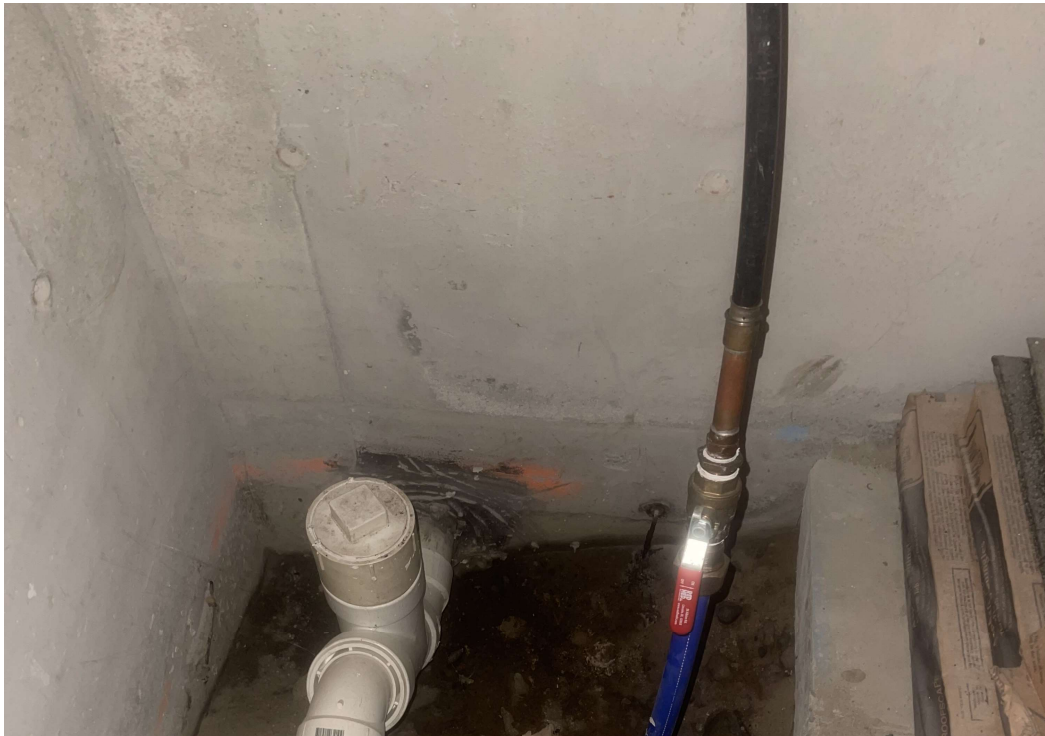
## Distance from private water supply well or suction line (Locate on site plan)

- ▶ No setback when doing a Title 5 Inspection
- ▶ 10' minimum on new construction

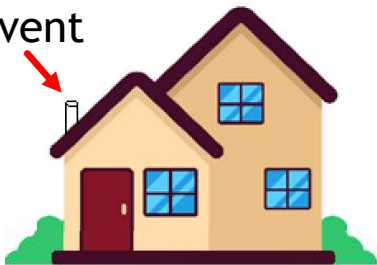
Roof vent

In this illustration, air from the roof vent would be able to pass through the system

- ▶ Flat spot & sags in main line can cause solids to be left behind, leading to blockage.
- ▶ Can allow pipes to freeze
- ▶ Sags or low spots in the pipe can obstruct extremely important airflow into the system. Without atmospheric oxygen, systems will go anaerobic and develop biomat causing SAS to go into hydraulic failure. (NOTE: Biomat is the #1 cause of failure in septic systems)

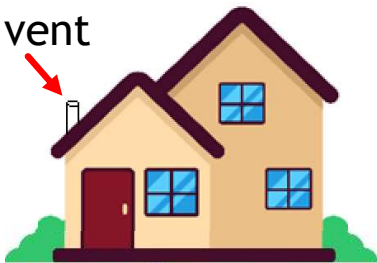
Roof vent

In this illustration, air would not be able to get into system via roof vent

Biomat

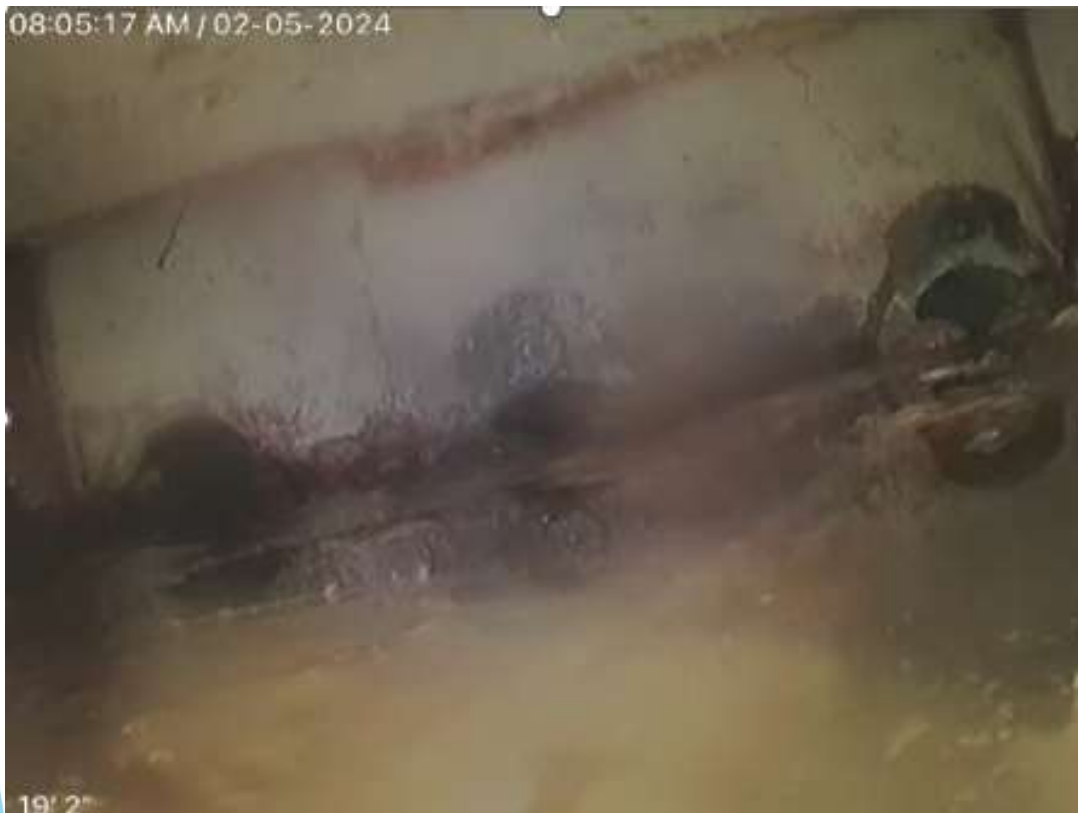
# Distribution Box Inspection

- ▶ Water level appears high
- ▶ Box structure appears OK

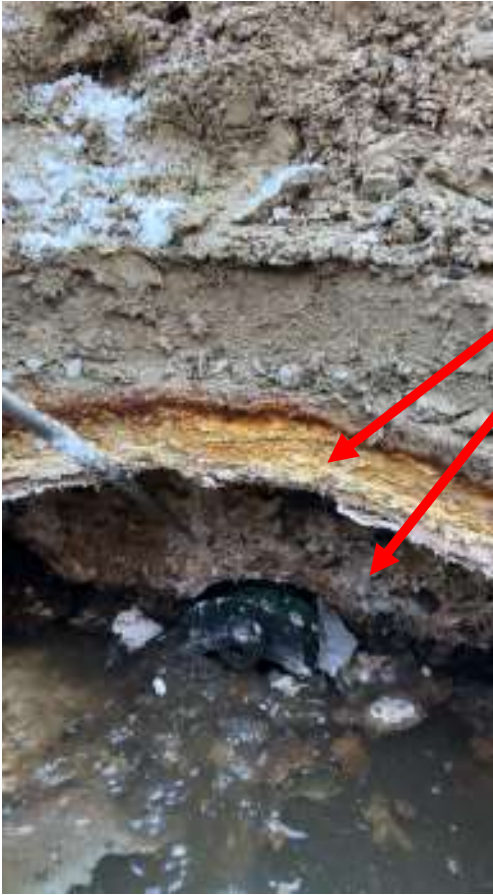
# Distribution Box Inspection

- ▶ Hydrosulfide rot is very common

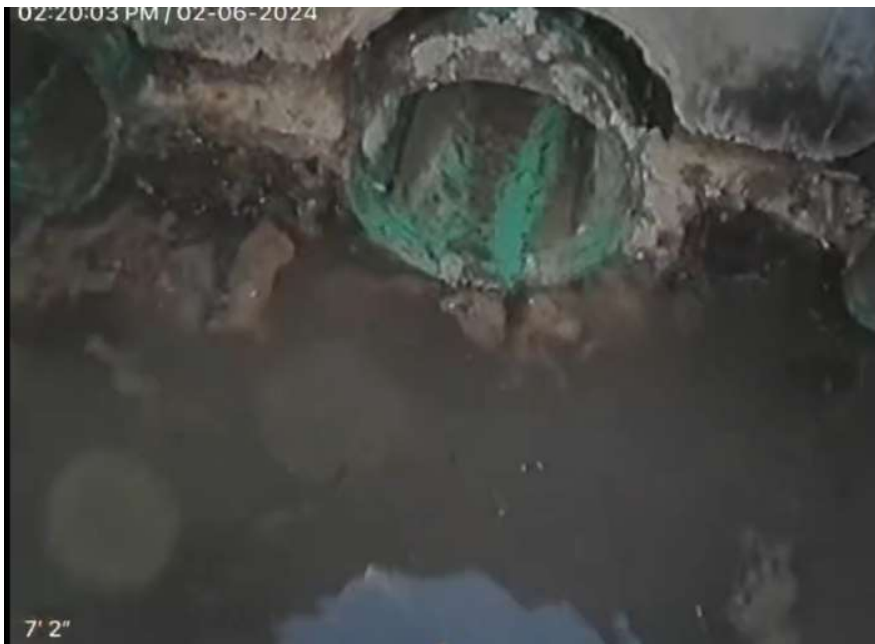
# Distribution Box Inspection

- ▶ Distribution box is not water-tight, some of the effluent may not get secondary treatment

- ▶ Is it just surface rot? (possibly make note of condition.)  
Example - “D-box is brittle, but not leaking at the time of inspection”

- ▶ Is the box structurally unsound or leaking? (conditional pass)  
Example “D-box rotted, needs to be replaced”
- ▶ Be sure to consult with Board of Health & get necessary permits before making any repairs

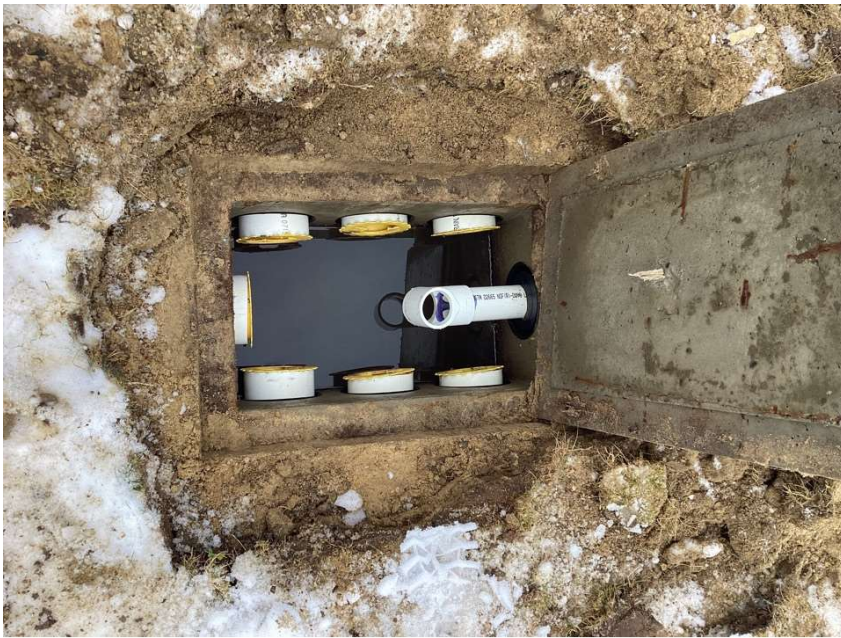
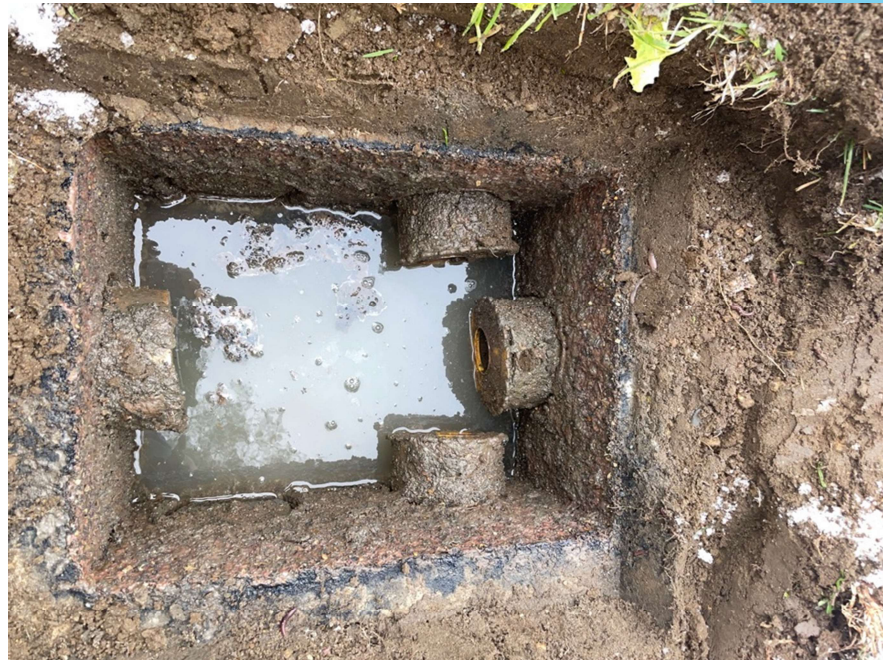
# Distribution Box Pictures

- ▶ Including a picture of the distribution box in your report works as great evidence of what the working level and the structure of the box was at the time of the inspection. This can prove to be helpful if anyone ever questions your findings.

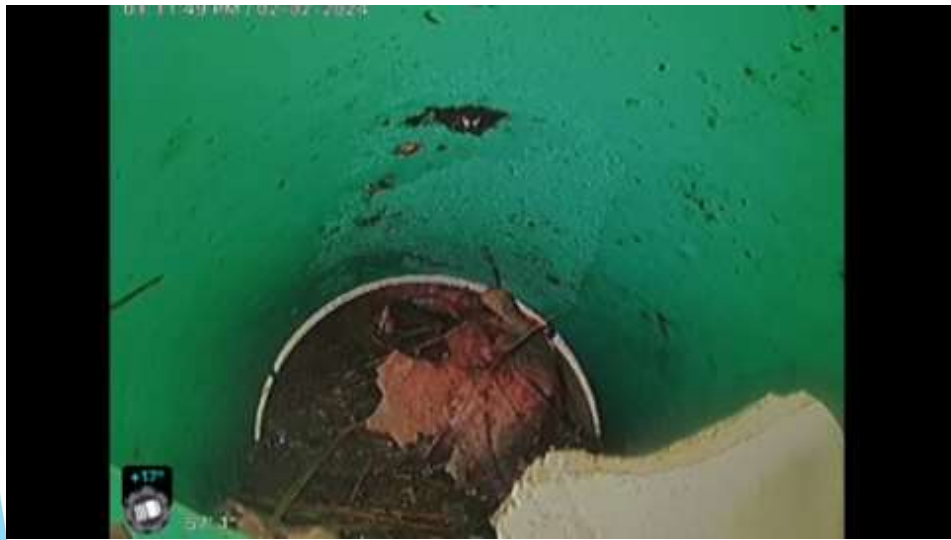
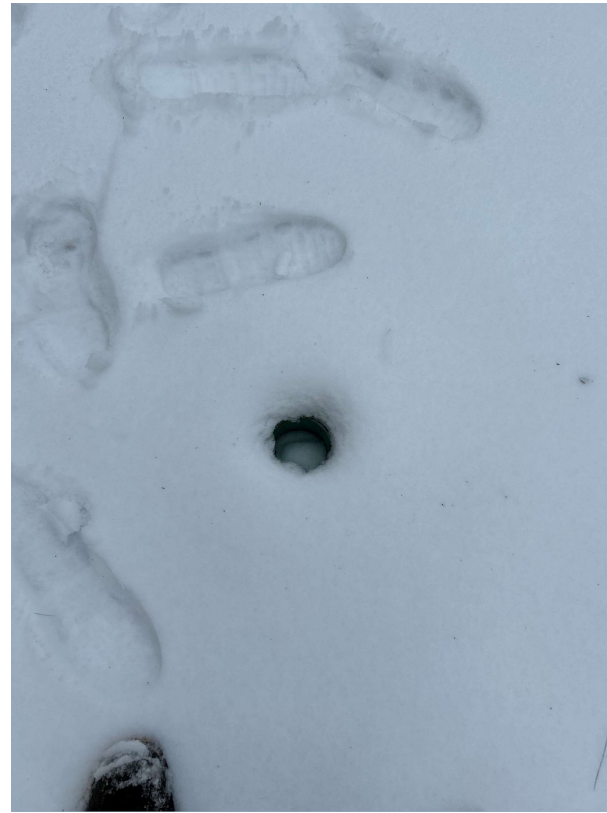
# Vent Pipe Missing

- ▶ Leaves, acorns and other debris obstructing airflow will shorten the lifespan of the system
- ▶ Should be a conditional pass - be sure to consult with Board of Health and get necessary permits if necessary

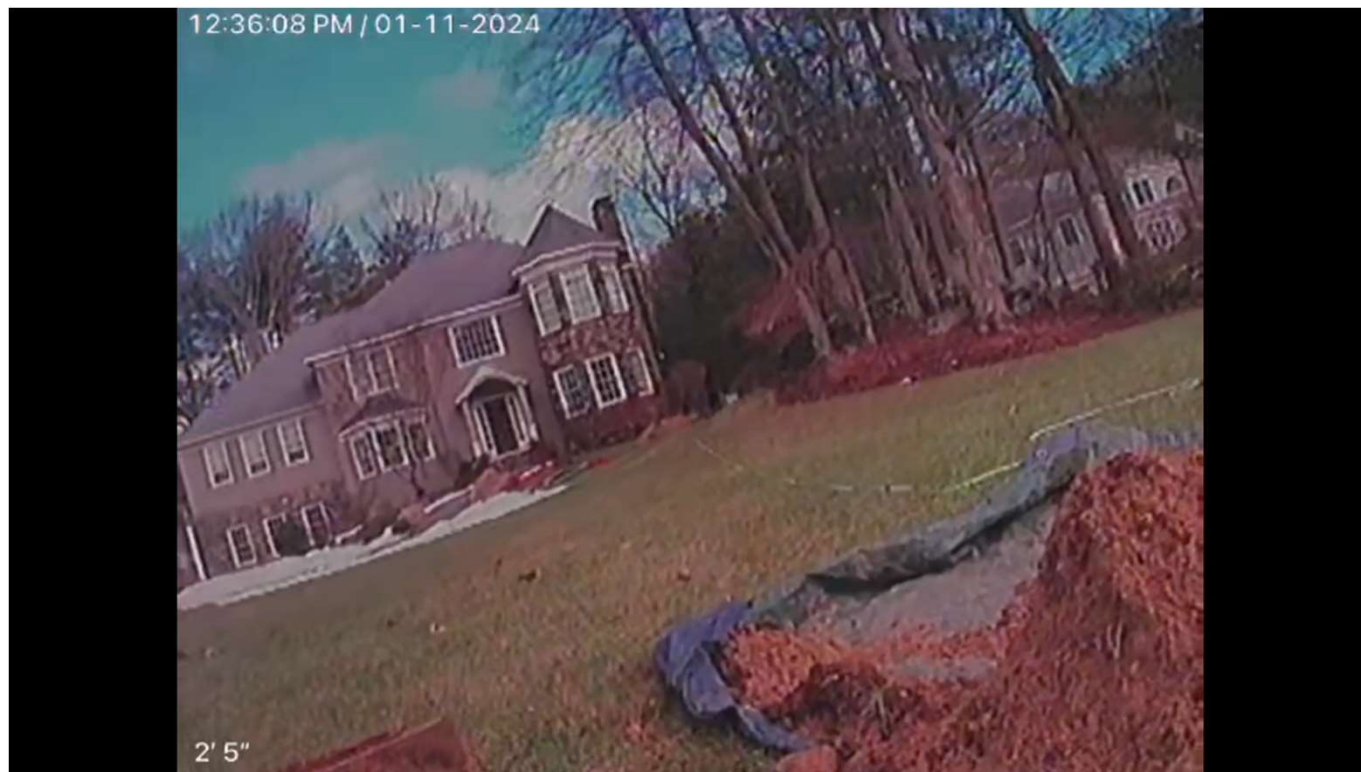
# Inspecting a Leaching Galley

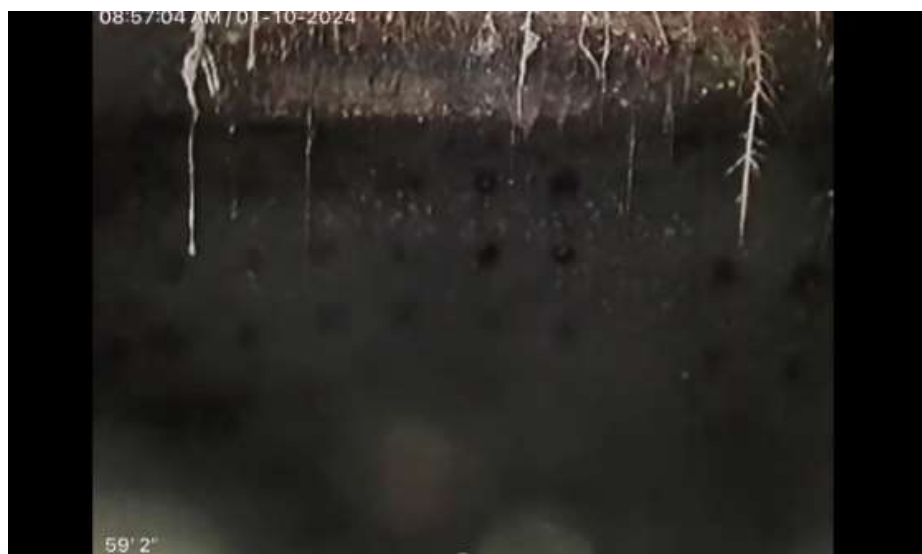
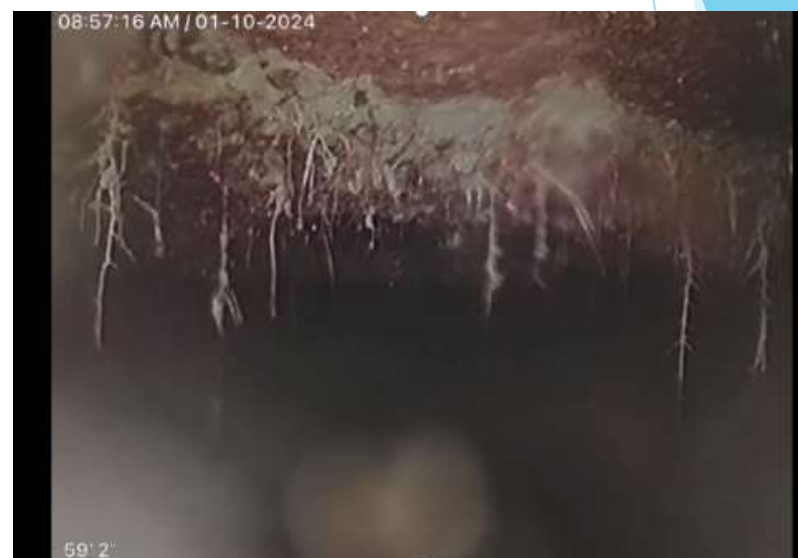
# Light root problem, appears to be coming in from cover on top of pit

- ▶ Should nearby trees or bushes be removed to prevent problem from getting worse?
- ▶ This could be a note or if more severe could be a conditional pass allowing board of health to make a decision on a remedy.

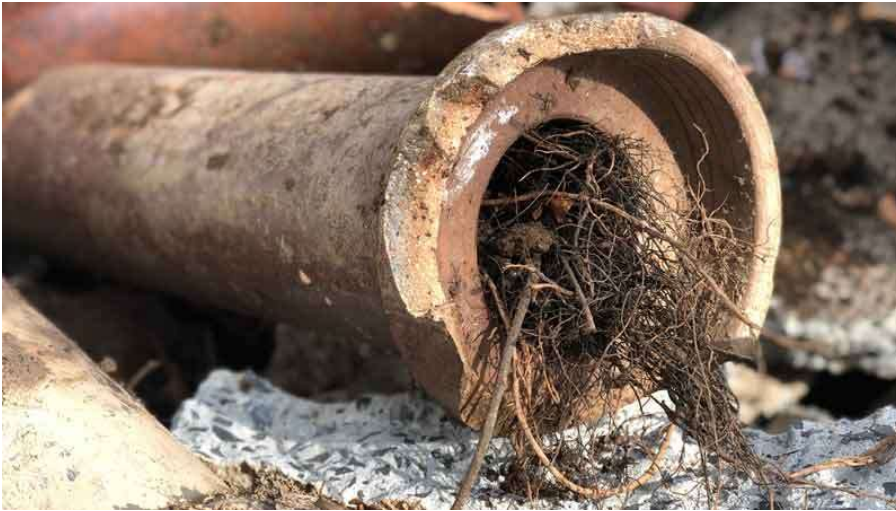
# Advanced Root Problem

Failure or Conditional Pass, depending on how extensive the root problem is.

Also depends on what pipe the roots are in (house to tank, tank to d-box, header pipes or is it throughout the entire SAS

- ▶ Establishing how severe the root problem is very important.
- ▶ Can roots be removed with drain cleaning equipment and/or replacing sections of pipe and making pipes water-tight.
- ▶ Often times, tree(s) or bush(es) will need to be removed to prevent re-occurrence.
- ▶ Always consult with Board of Health and obtain necessary permits before commencing any work.

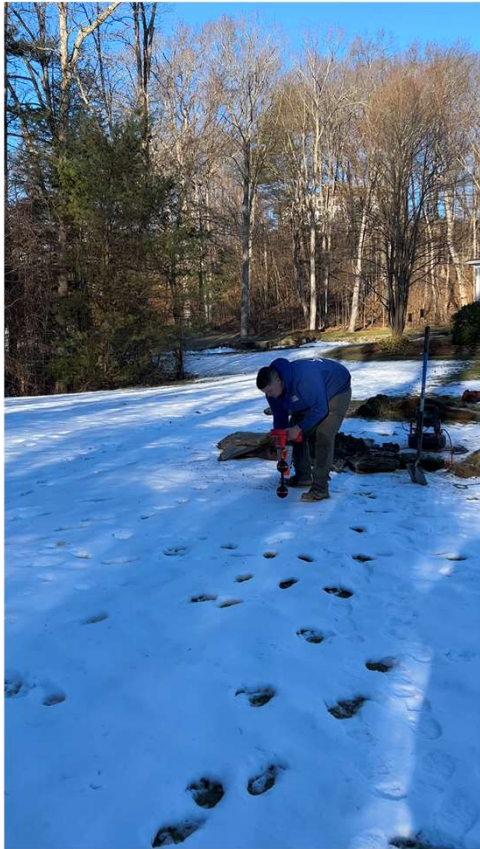
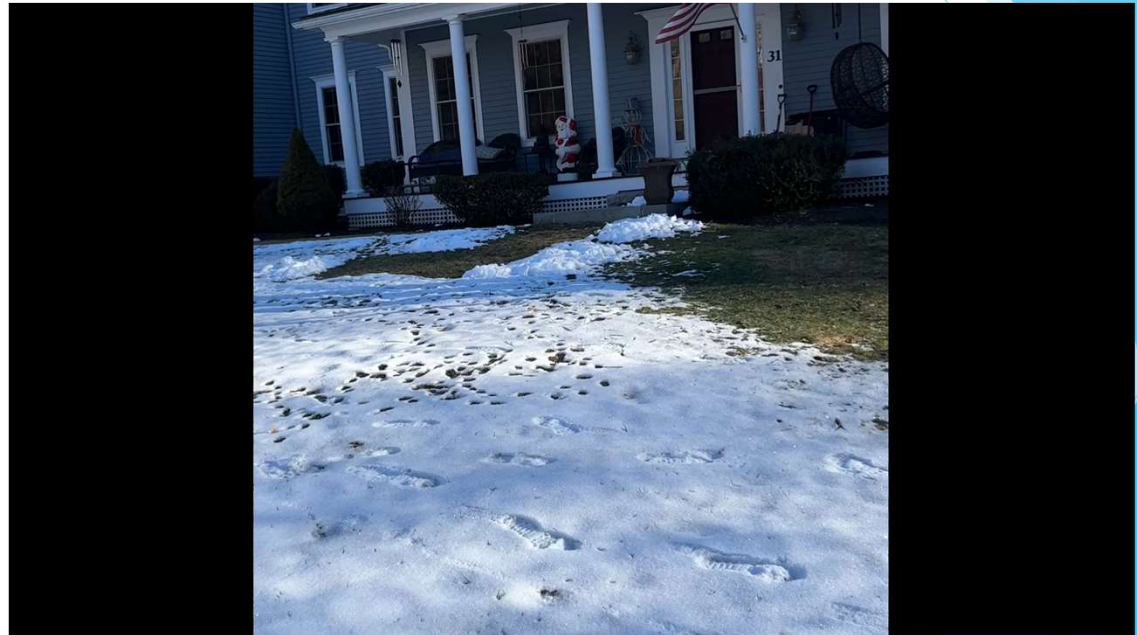
# Using Camera & Locator to layout system to determine setbacks
